# Manhole Inspection Summary

Manhole # S23K\_\_023MH

Insp Date: **6/10/08 12:30 PM**

**Location** Address: **221 Parrish St**

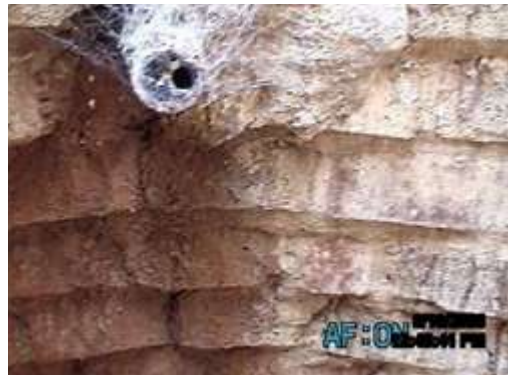
abandoned line or bleeder

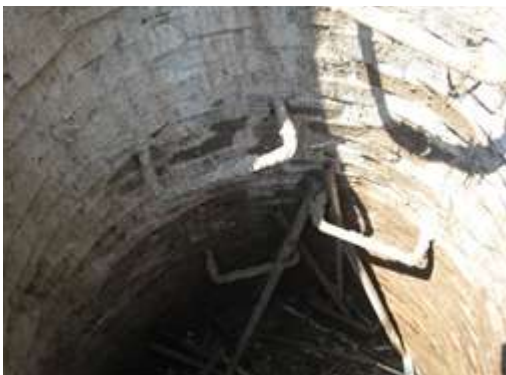
Defect 9

corbel infiltration

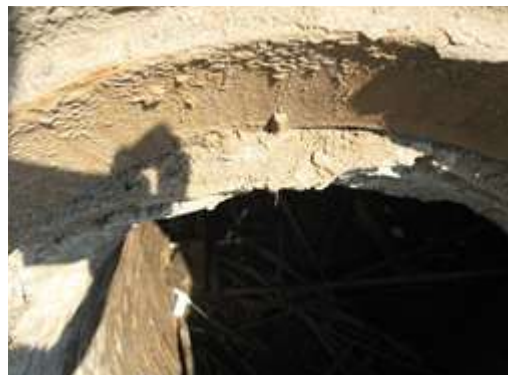
Defect 8

debris

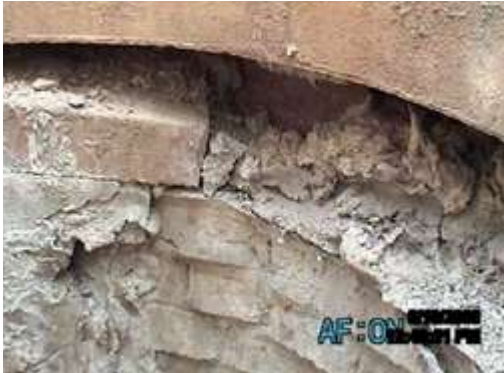
Defect 5

infiltration frame-lid connect  
Frame offset 1.5 Inches

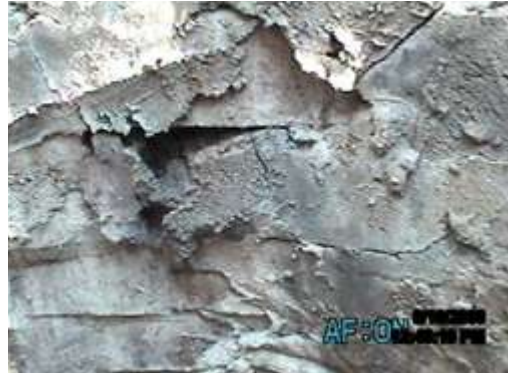
Defect 4

missing mortar and bricks

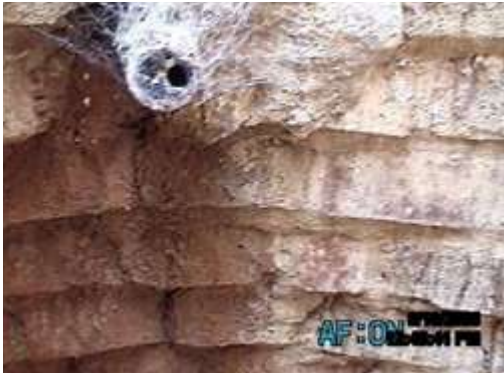
Defect 6

missing mortar corbel

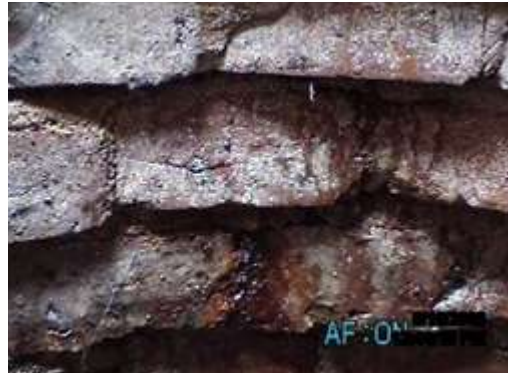
Defect 1

corbel infiltration  
and abandoned line or bleeder

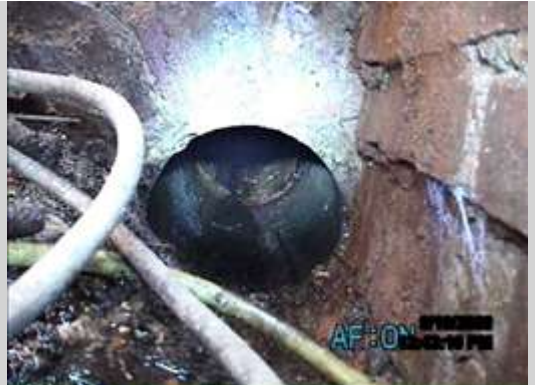
12 O'Clock Outflow

8 in. Circular Gravity Sewer  
Pipe Out @ 12 O'Clock

Pipe Height: **8.4** (in.) Rod and Bar (Angled)

Pipe Material: **Clay** ☐ Pipe Lined

Invert Depth: **8.44** (ft.) Flow Characteristics: **Slow**

Infiltration: **None** Pipe Seal Cond: **Sound**
